LASER TOOL

Precise Measurement
and Correction of Belt
Drive Misalignment

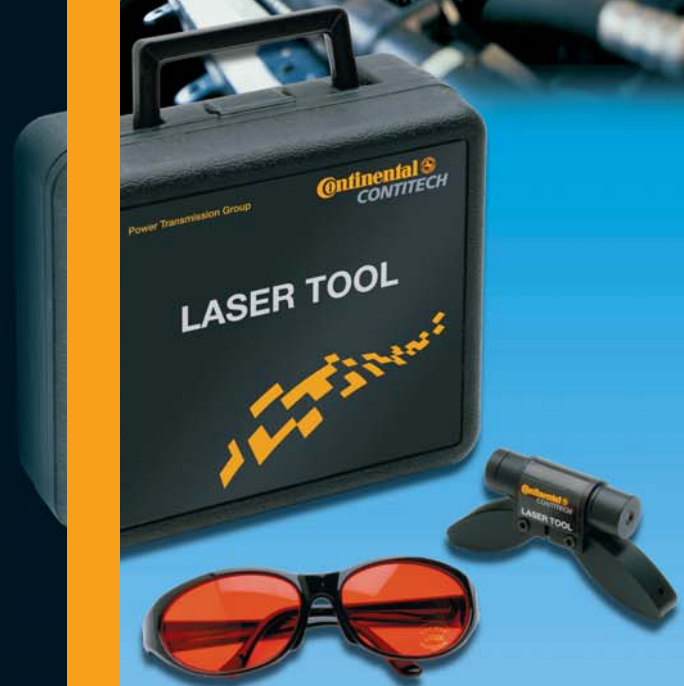
Alignment measurement is performed by positioning the laser midway between the ribs of a belt pulley with the laser beam projected onto the opposite belt pulleys. The operator can then see immediately whether or not the pulley is correctly aligned.

The most common types of misalignment on serpentine drives are offset and angular misalignment. Both types are easily identified with the help of the laser tool from ContiTech. Based on the readings, pulley misalignment can be resolved quickly to ensure perfect functioning of the entire belt system.

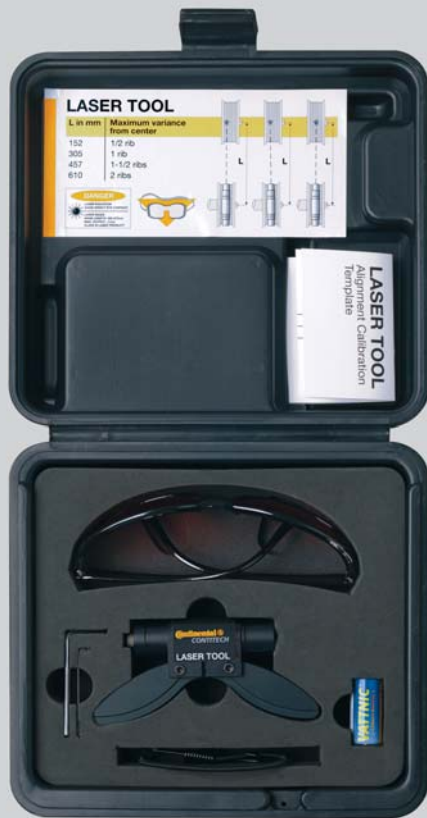
Laser Tool from ContiTech

- Accurately identifies pulley misalignment
- Easy to use
- Includes setting gauge for calibration checks
- Safety glasses are included
- Extremely versatile
